Facility Condition Assessment Services

Facility Condition Assessment

**For
City of Los Altos
Classrooms 16-18
97 Hillview Avenue
Los Altos,
California 94022-3740**

Date of Report: June 10, 2016

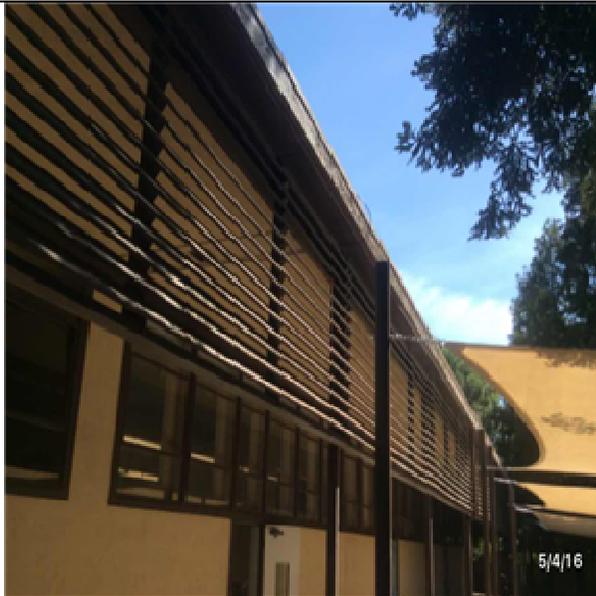
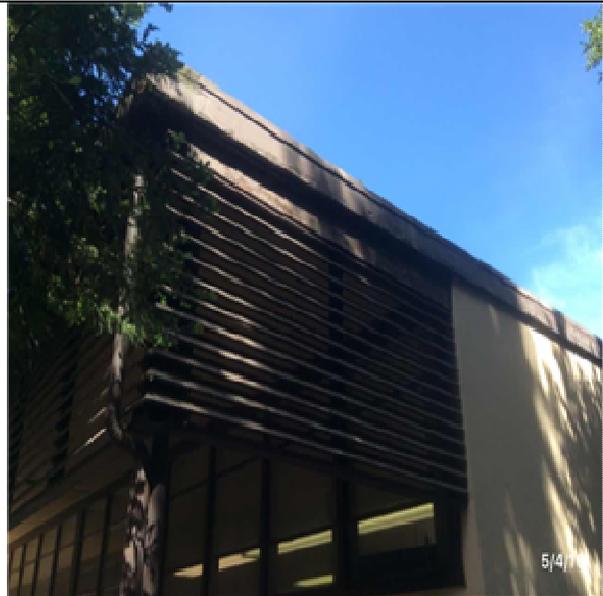
B2014 Exterior Sun Control Devices:- View of Exterior Sun Control Louvers

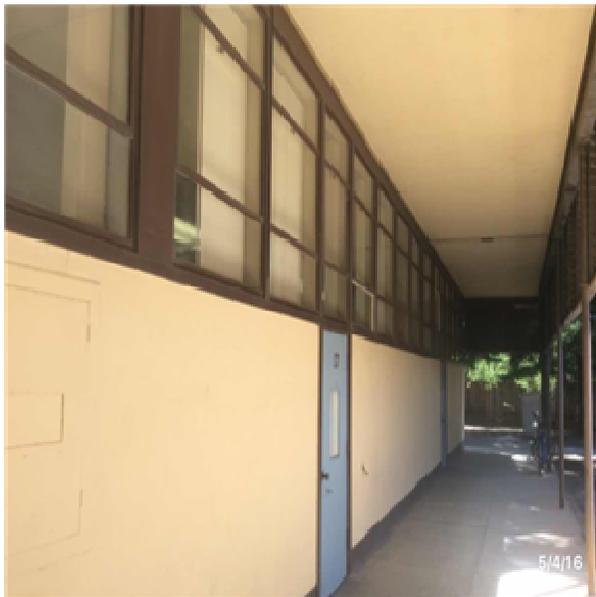
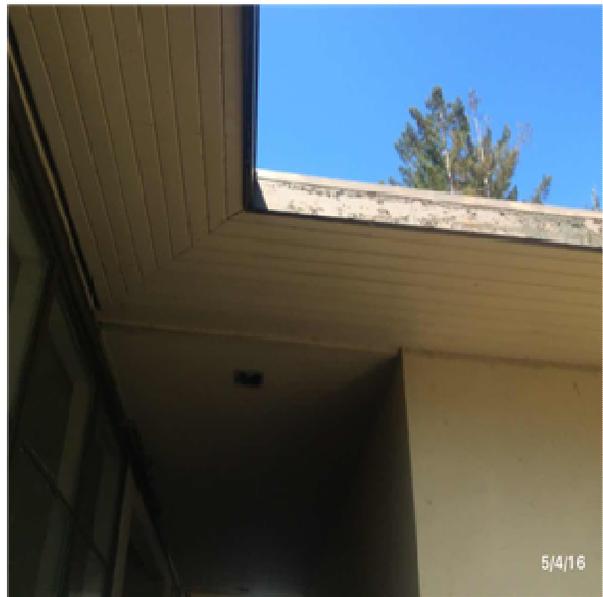
The exterior soffits appeared to be in fair condition; therefore we do not anticipate any actions during the study period. We do however recommend repainting of these surfaces later in the study period to maintain the appearance of the building and also protect the asset.

B2016 Exterior Soffits:- View of Exterior Soffits

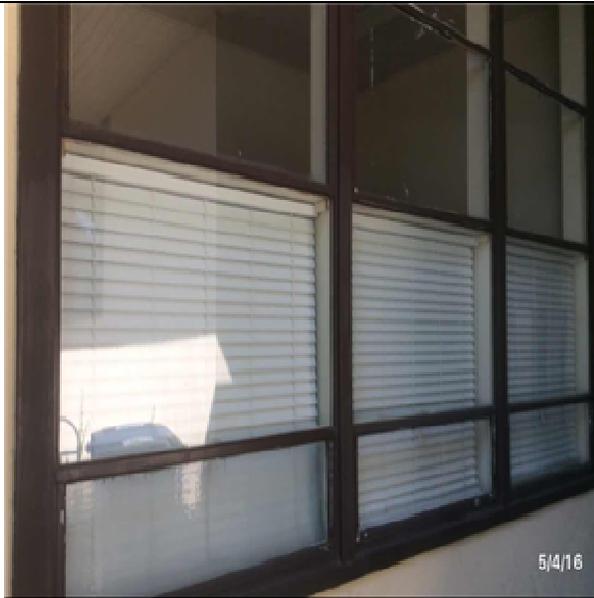
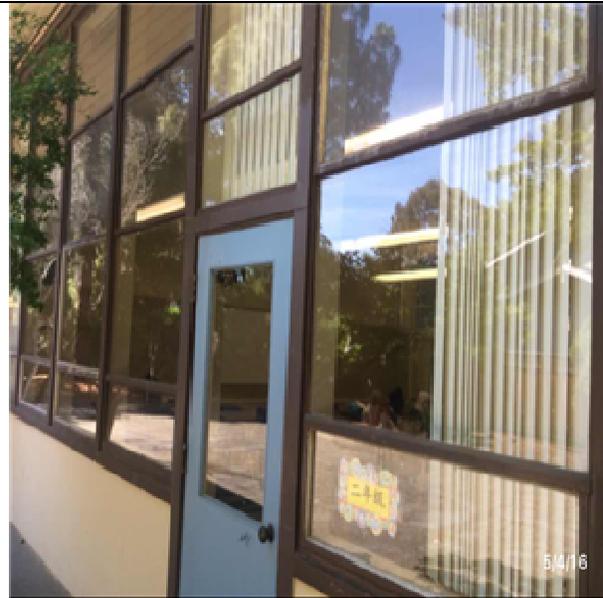
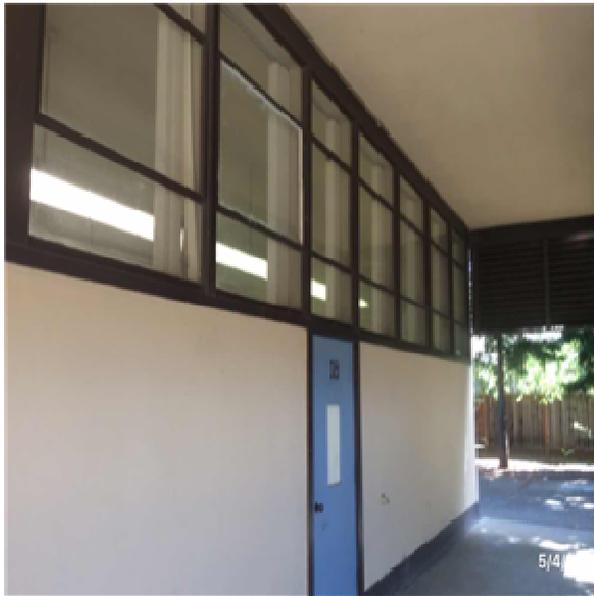
The windows at the building were observed to be in poor condition. We have assumed the windows to be original based on the current condition, which would put the windows well past their useful life. Glass has been replaced recently due to difficulty of operation, and the frames showed signs of rust and corrosion. We recommend replacing the window immediately in order to maintain the appearance and security of the building as well as prevent water penetration.

B2021 Windows:- View of Steel Window Units - Casement, Double Hung, Vent or Sliding

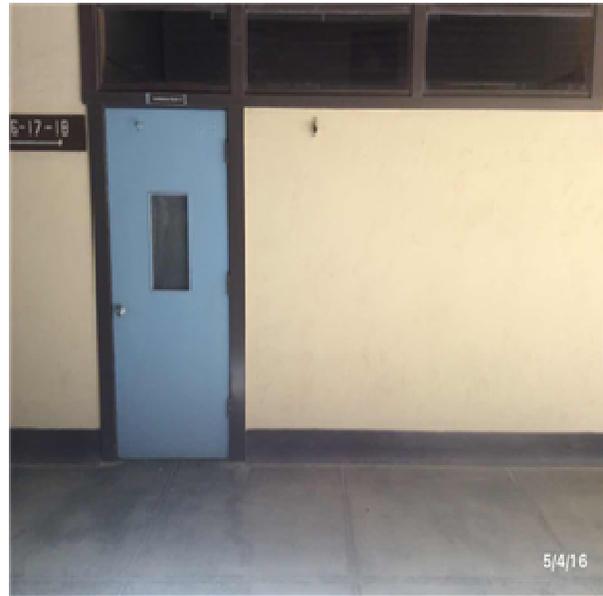
The wood doors at the building were observed to be in poor to fair condition. We have assumed the doors to be original based on the current condition, which would put the doors well past their useful life. Some doors have been repaired but there are signs of degradation. We recommend replacing the doors immediately in order to maintain the appearance and security of the building as well as prevent water penetration. The new door surface finish and door frames will require repainting later in the study period. The cost of this work has been included within the amount to undertake the repainted of the exterior walls.

B2032 Solid Exterior Doors:- View of Single Solid Core Wood Doors

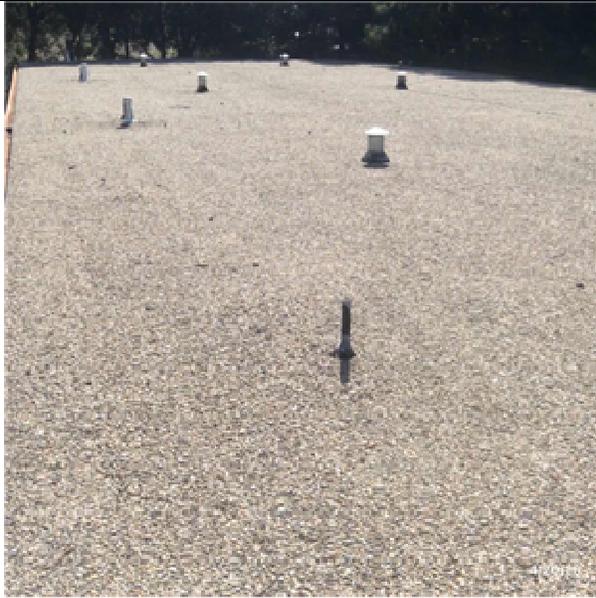
The BUR covering appeared to be in poor condition with evidence of leaks observed. The maintenance personnel also verified reported roof leaks. There is deterioration due to age and other similarly aged roofs to the Community Center have already been repaired. We are unaware of the age of the roof covering, however we assume it to be more than fifteen years of age, therefore based on the typical EUL of twenty years for this type of covering and current observed condition, we anticipate replacement early in the study period.

B3011 Roof Finishes:- View of BUR (Built-up Roofing) System

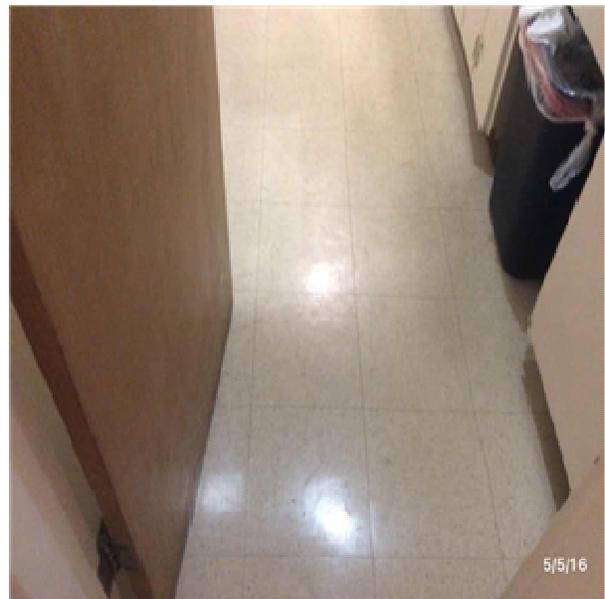
The floor finishes appeared in poor - fair condition throughout the building. The vinyl tile have a EUL of eighteen years; however, considering the observed condition, we have extended the RUL on this flooring to later in the study period. The ceramic tile at the restroom was in fair - poor condition given its age. The ceramic tile has a EUL of thirty years. We did not observe any broken or loose tiles or missing grout; therefore, we expect the ceramic tile to last beyond the study period. The Laminate wood floor appeared to be in fair condition we do not anticipate repair or replacement during the study period.

C3024 Flooring:- View of Vinyl Composite Tile (VCT)

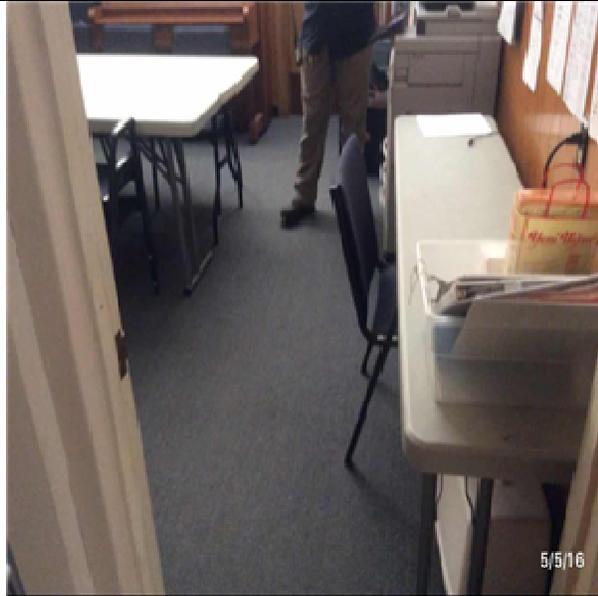
The carpet at the offices is in poor condition. We are unaware of the age of the carpeting, however we assume it to be more than fifteen years of age, therefore based on the typical EUL of ten years for this type of covering and current observed condition, we anticipate replacement early in the study period.

C3025 Carpeting:- View of Broadloom Standard without Padding
